Topanga Creek Restoration: Rodeo Berm Removal

Rosi Dagit

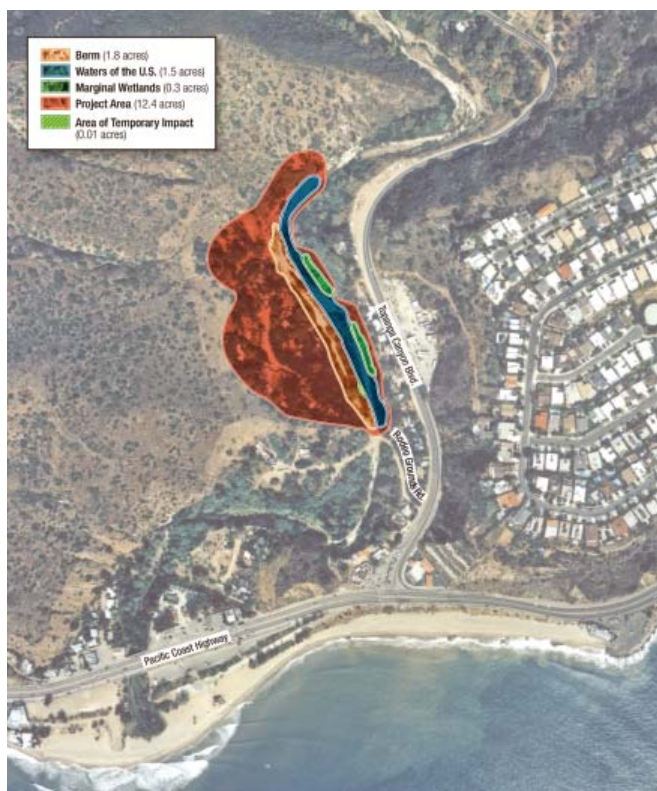
Figure 2. Project Impact Area
