Texas Crossing Removal in Malibu Creek

Abstract

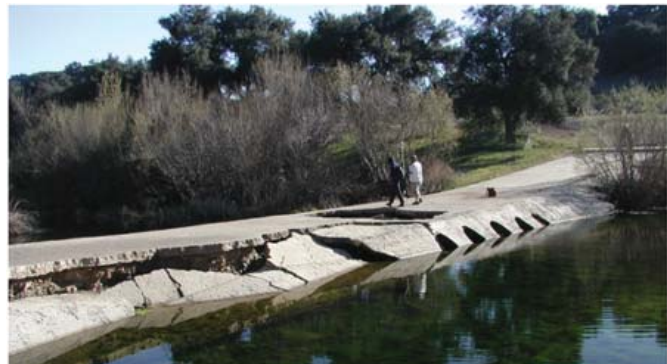
The Texas crossing in Malibu Creek, owned and operated by State Parks, was an elevated creek crossing in disrepair. Undersized culverts had led to massive scouring by streamflows and the collapse of portions of the 220 foot long stretch of concrete forming the base of the crossing. The crossing posed a safety risk for users and caused severe degradation of upstream and downstream habitat. Elevated road crossings such as this often end up functioning similarly to dams, in that they cause water slowing and sediment build-up immediately upstream of the structure. As the upstream bed becomes elevated, water flows over the top of the crossing and scours out the stream bed at the downstream end of the crossing. This scouring eventually creates a deep pool on the downstream end, which forces upstream migrating fish to jump onto the concrete road bed and then swim through 30 feet of shallow water, across the road, to migrate upstream. The jump height for fish was five feet at this Texas crossing (Figure 1). Downstream erosion on both banks of the stream was also severe.

The Texas crossing was 220 feet long, 30 feet wide, 10 to 12 inches thick, and was constructed of steel reinforced concrete. There were five 24 inch corrugated metal pipe culverts running through the center of the structure that no longer transported water due to excessive sedimentation upstream of the crossing.

Figure 1. Dilapidated Texas Crossing Prior to Removal,
Photo: Heal the Bay

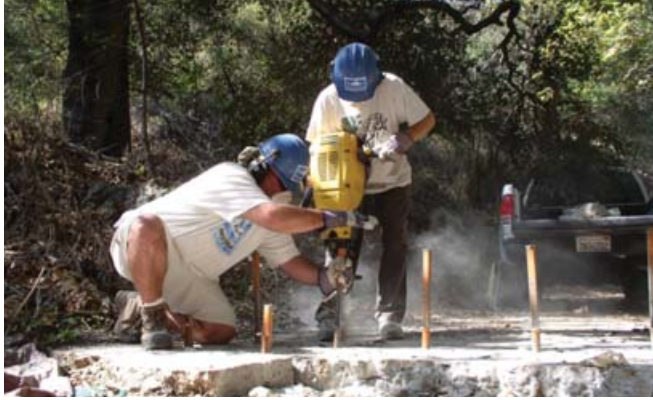
Figure 2. Drilling Holes with the Gas Powered Jackhammer and Placing Feathers and Wedges, *Photo: Heal the Bay*

The Texas crossing barrier removal project took 39 work days between October 4, 2006 and November 28, 2006. Approximately 1/3 of the structure was located in the water, and was removed by hand, using a gas powered jackhammer/drill, and feathers and wedges (Figure 2). This manual technique enabled the removal of concrete that was in contact with the water while minimizing environmental damage. The feather and wedge removal process can be seen in the "Adiós Texas Crossing" time-lapsed video available on Heal the Bay's website at <http://www.healthebay.org/videos/default.asp>.

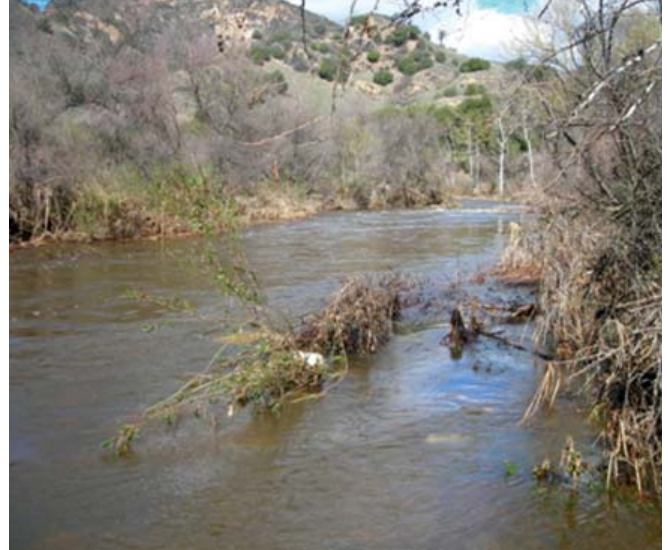
The site is performing as expected. The large scour pool below the crossing is filling in and a riffle has formed in the former crossing location (Figure 3). Additionally, the sediment deposit behind the old crossing has been dramatically reduced, despite the fact that no large storm events (greater than four inches in 24 hours) have occurred since the removal (Figure 4). No head cutting or upstream channel erosion has occurred, as is typical with these projects and the stream bed is relatively stable. We expect the site to continue to improve over time while we wait for some more significant rain events.

Figure 3. Texas Crossing Removal Site after Rain Storm, January 29, 2007, *Photo: Heal the Bay*

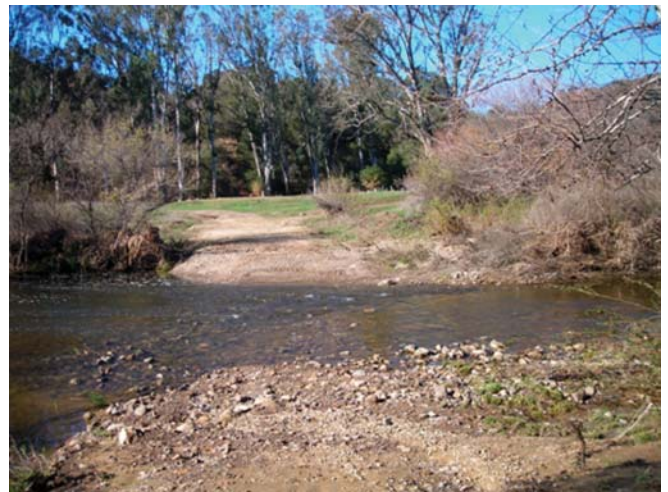
The Texas crossing will not be replaced and has opened approximately 1 mile of high quality habitat for spawning and rearing for the federally endangered southern steelhead trout upstream of the Rindge Dam. Since the crossing was removed, cobble and gravel have replaced finer sediments and algae on the stream bed, providing improved habitat for benthic invertebrate species and fish at this location.

Figure 4. Texas Crossing Removal Site after Rain Storm, January 9, 2008, *Photo: Heal the Bay*
