Sustainable Infrastructure: The Elmer Avenue Neighborhood Retrofit

EDWARD BELDEN, MICHAEL ANTOS, KRISTY MORRIS, & NANCY L.C. STEELE

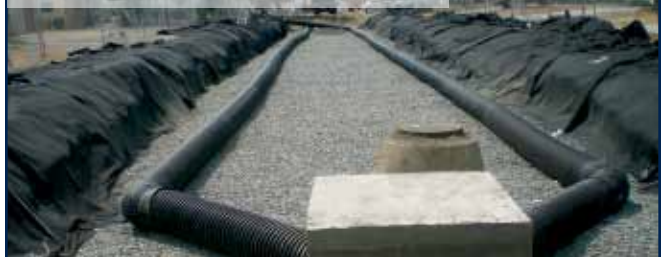
Figure 3. Infiltration Gallery

The Elmer Avenue Neighborhood Retrofit Project is designed to reduce, capture, treat, and infiltrate runoff from forty acres using an infiltration gallery under the street (Figure 3),

The stormwater flowing to Elmer Avenue (run-on) from the 40-acre neighborhood to the north now enters catch basins that convey water into two infiltration galleries underneath the street. The bottomless catch basins allow particulates to settle out of the water before it enters the infiltration galleries. The two basins work in series, with water filling one before entering the next, which must also then fill before flow is conveyed to the gallery. The catch basins have no concrete bottoms, so some infiltration occurs there as well. The infiltration galleries below the street each consist of two 18-inch-diameter perforated pipes in a gravel bed five feet deep (Figure 5). Each gallery runs the 36-foot width of the street; the north gallery is 250 feet long, and the south gallery is 100 feet long.

The infiltration galleries are capable of infiltrating flow running on to Elmer Ave from “upstream” neighborhoods generated during a 2-year 24-hour storm (2.6 inches). The peak flow and volume of the 2-year storm are estimated to be about 10 cubic feet per second and 5 acre-feet, respectively. Based on historical rainfall data, the galleries are expected to infiltrate about 16 acre-feet of runoff annually.

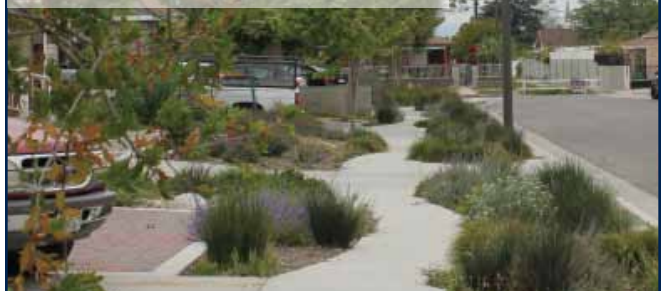
Figure 4. Residence and Right-of-Way Improvements

bioswales along the public right-of-way, permeable surfaces for walkways and driveways, rain gardens and rain barrels to utilize and capture water from downspouts, as well as drought-tolerant landscaping and drip irrigation to lower water usage and utility bills. Infiltration is an effective stormwater management strategy along Elmer Avenue and in the Sun Valley area because the soil is highly permeable (Los Angeles County Department of Public Works [LADPW] 2004).

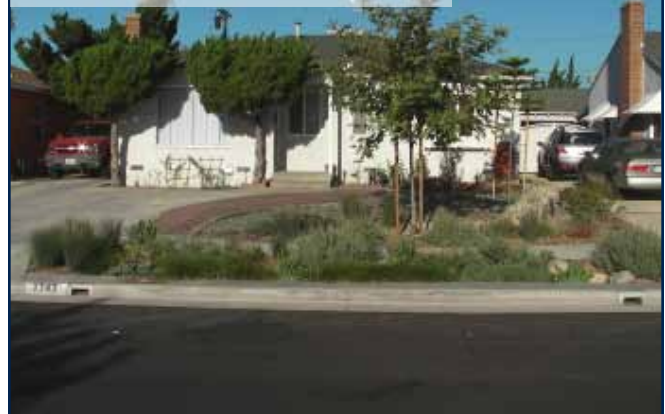
Figure 6. Residence and Right-of-Way Improvements: One Year Post-Project

Thirteen homeowners chose to have some or all of the LID improvements installed on their property. Each participating home received site-specific designs to meet individual needs such as additional parking with permeable pavers or drought-tolerant turf alternatives. The design for private property used a similar plant palette as the public right-of-way to provide a continuous landscape design. Installation of the private and public property designs was sequenced so grading and plantings occurred in similar timeframes and did not conflict with each other. The bioswales have curb inlets and driveway drains to direct flows into the system. The swales include plants and native soils to mimic natural treatment and infiltration processes (Figure 6).

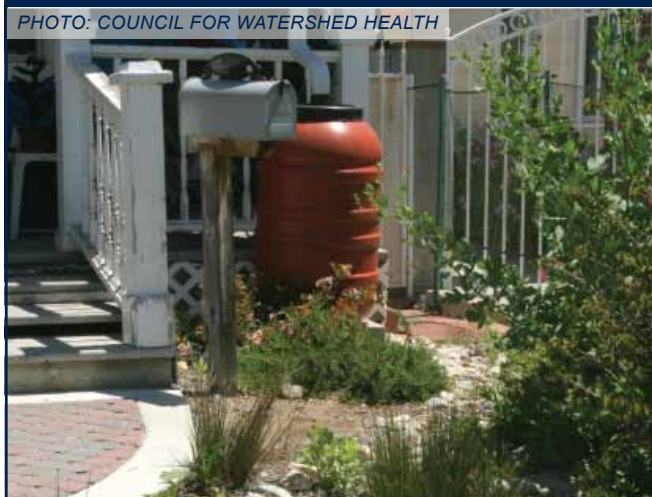
Figure 7. Residence Improvements

Community involvement continues today with residents helping to monitor the landscapes. Maintenance and training days for all residents are held quarterly on Saturdays to cover the items in the maintenance manual. The manual provided to each house has a calendar of activities to be performed, from cleaning the inlets to trimming native plants, and includes contact numbers for additional resources (Figure 7).

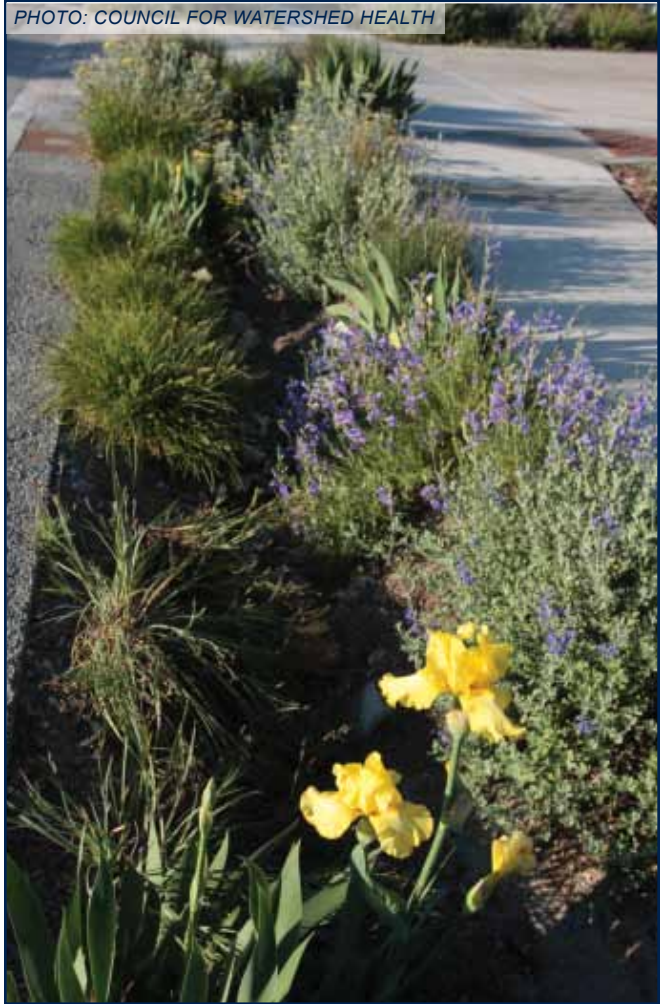
Figure 8. Bioswale

- Qualitative assessment suggests plant survival rate is high.
- Weed cover remains particularly low, which may be attributed to proactive residents who routinely weed the bioswales in front of their homes.

- Trash carried by the stormwater and the wind is caught in the bioswales and then removed by the residents.
- As was expected, mulch levels in the bioswales are decreasing since installation. Continued monitoring will determine the need and frequency to reapply mulch.

- Unexpected amounts of sediment are accumulating on the east side of Elmer Avenue causing some inlets and swales to require additional maintenance. The effect of the increased sediment is primarily an aesthetic concern, but will be assessed over time.

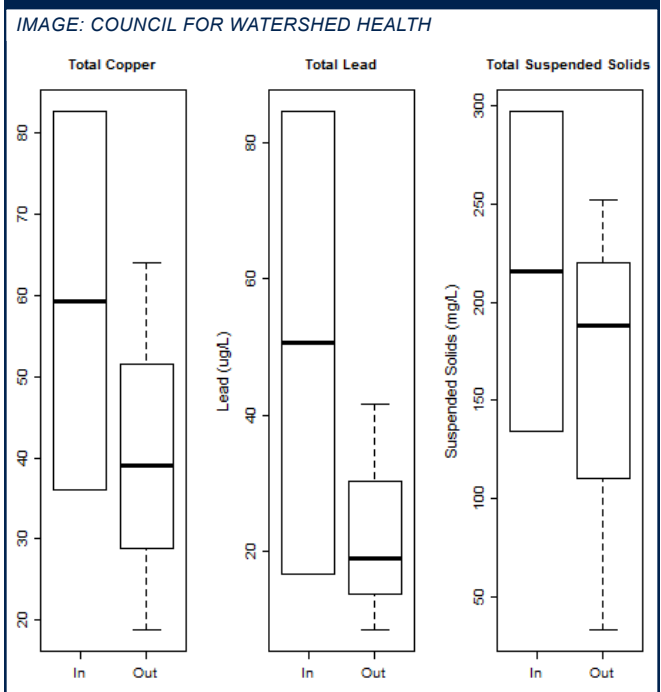
Figure 9. Concentrations of Stormwater Copper, Lead, and Total Suspended Solids at the Street Inlet vs. Catch Basin Outlet

The preliminary findings indicate that settling of sediments in the catch basin is reducing the concentration of metals and TSS in the flow entering the infiltration gallery (Figure 9). No VOCs were identified in the samples from either the inlets or the infiltration gallery. It should be noted that these data are preliminary, and the number of data points is too small to determine statistical significance.

Water quality monitoring to assess the performance of the infiltration gallery and pre-treatment commenced in 2010. Each gallery has pre-treatment catch basins for settling out debris and sediment before allowing water to infiltrate for groundwater recharge. At present, two automated samplers and two automated flow sensors monitor water quality at two points: (1) along the street before the water enters the catch basin and (2) at the entrance to the infiltration gallery following catch basin pre-treatment. During the 2010–2011 storm season, time-weighted and flow-weighted composite samples were collected with accompanying flow measurements to determine event mean concentrations and pollutant loadings before the catch basins and as flow enters the infiltration gallery. Future monitoring will determine the effect of the bioswales on water quality (Figure 8). Total suspended solids (TSS), total and dissolved metals, nutrients, volatile organic compounds (VOCs), and conventional constituents, such as pH and electrical conductivity, are examples of the range of constituents that are monitored.

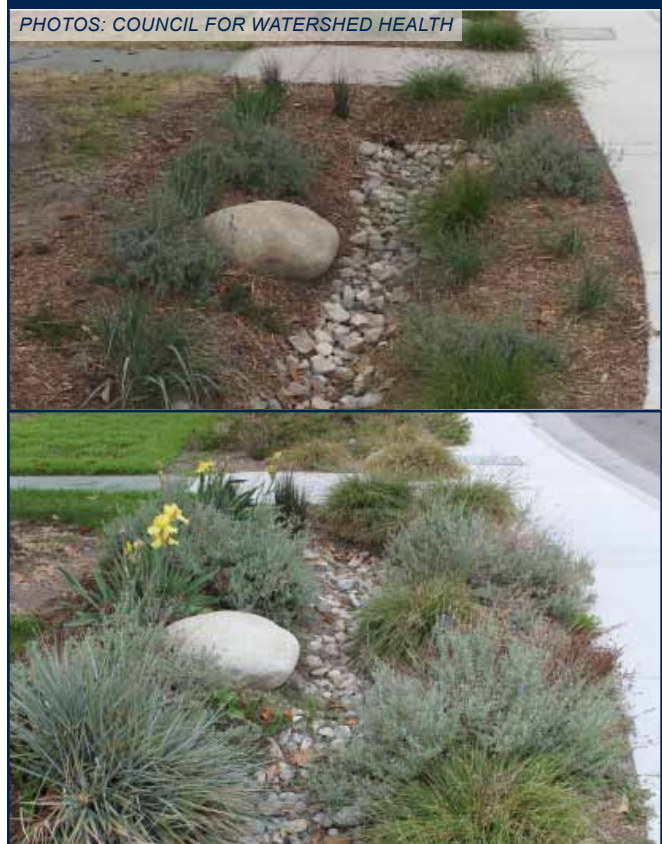
Figure 10. Bioswale Progress: June 2010 vs. July 2011

Visual surveys of Elmer Avenue’s bioswales are conducted quarterly to assess the plants’ health and growth. Photos are taken on a quarterly basis of each bioswale in a consistent manner to observe changes over time (Figure 10).

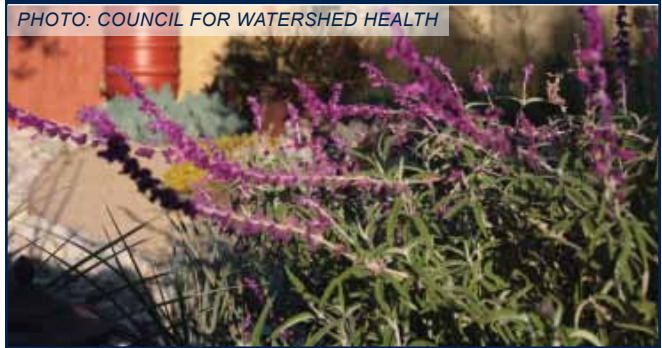
Figure 11. Thriving Plants (foreground) and Rain Barrel (background)

- The rain barrels are in good condition; barrels are receiving water from the storms and are being used by the residents.

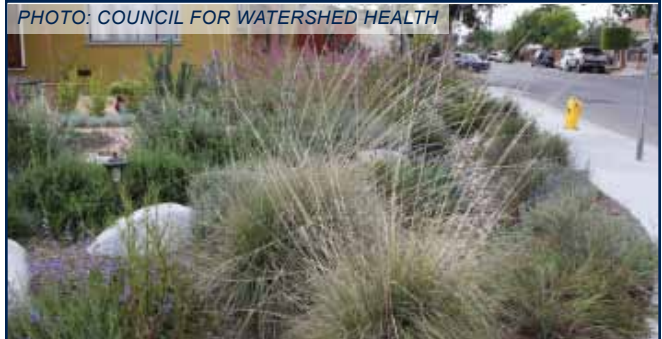
Figure 12. Thriving Residence Improvements

- 28% of respondents are familiar with the project.
- Of those who are familiar with the project, 88% feel influenced by its presence (Figure 12).
- 67% would consider purchasing a rain barrel if their neighbors had one.
- 80% of respondents feel that individuals can help reduce the amount of polluted water that flows to the ocean while adding to local potable water supplies.

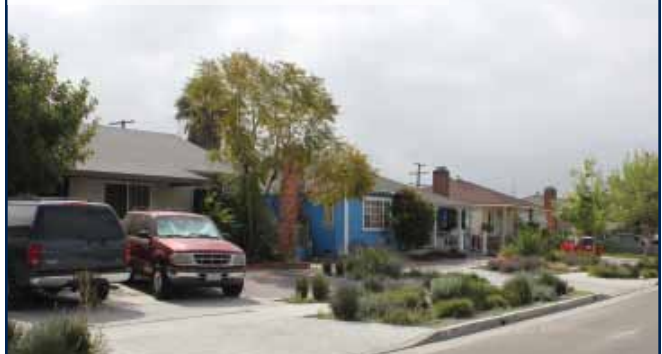
Figure 13. Elmer Avenue: Post-Project

Monitoring results suggest that many of the goals of the Elmer Avenue Neighborhood Retrofit project are being met. Continued monitoring of the project, and additional monitoring at the upcoming Elmer Paseo project (details below), will provide further knowledge about the value of sustainable infrastructural retrofits in Southern California. Numerous agencies, homeowners, residents, and municipalities throughout the region regularly tour Elmer Avenue as an example of sustainable infrastructure (Figure 13).

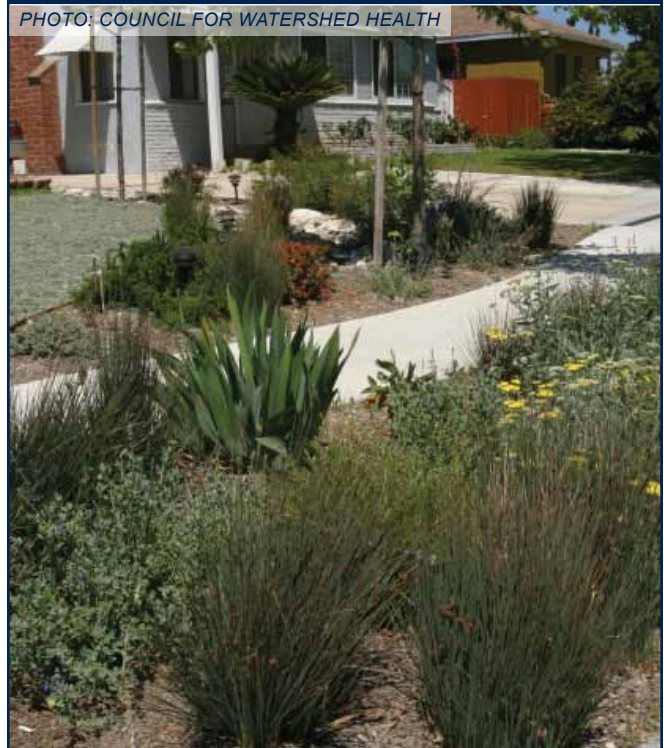
Figure 14. Residence and Right-of-Way: Post-Project

Monitoring along Elmer Avenue and the Paseo will provide valuable information on the performance of the various BMPs, the influence of these types of demonstration projects on the community, and additional information on what works and what is needed to convert the urban landscape into a healthy watershed (Figure 14).
